# Pre-Purchase Report

## Baron N[REDACTED]

2000 Beechcraft B58 Baron  
S/N TH-[REDACTED]

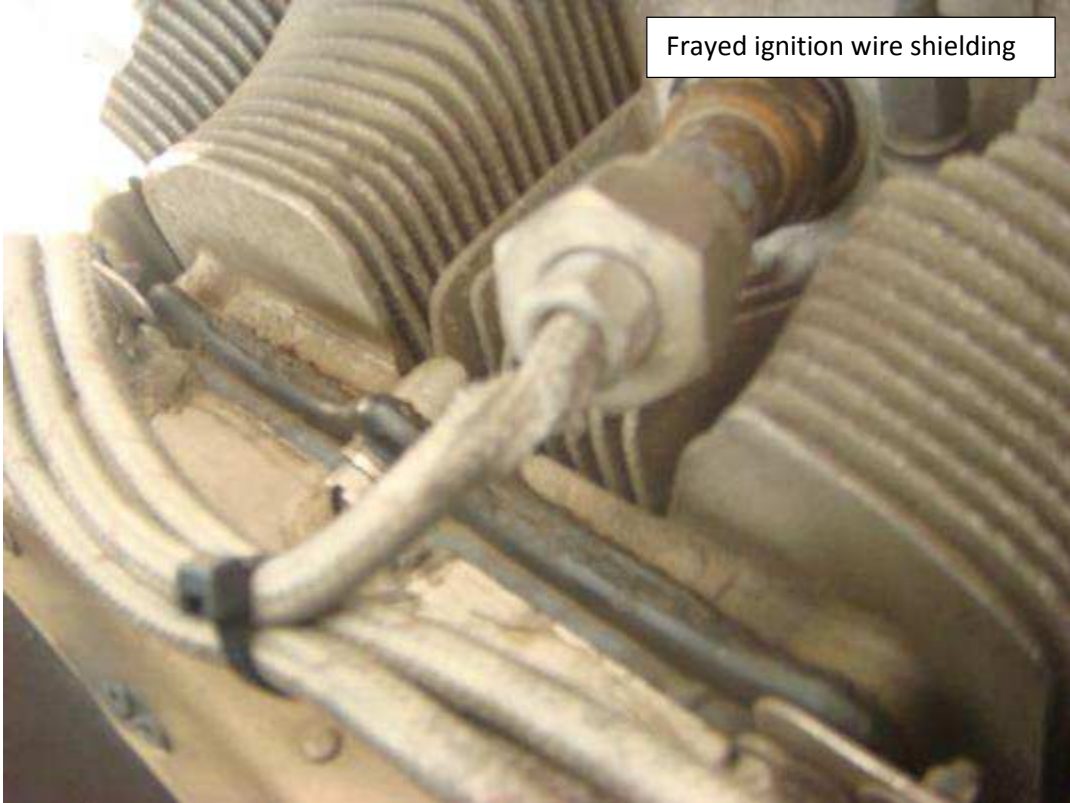
- The ignition harnesses on both engines were replaced at the annual in 2011. The harnesses look fairly new except for some torn shielding at the top plugs on the #4 cylinders of both engines. The shielding usually tears when mechanics twist the leads as they are installing the lead to the spark plug. There are repair kits available to replace the torn leads without replacing the entire harness. This should be done to prevent the insulation from wearing through and arcing the magnetos directly to ground.

Frayed ignition wire shielding

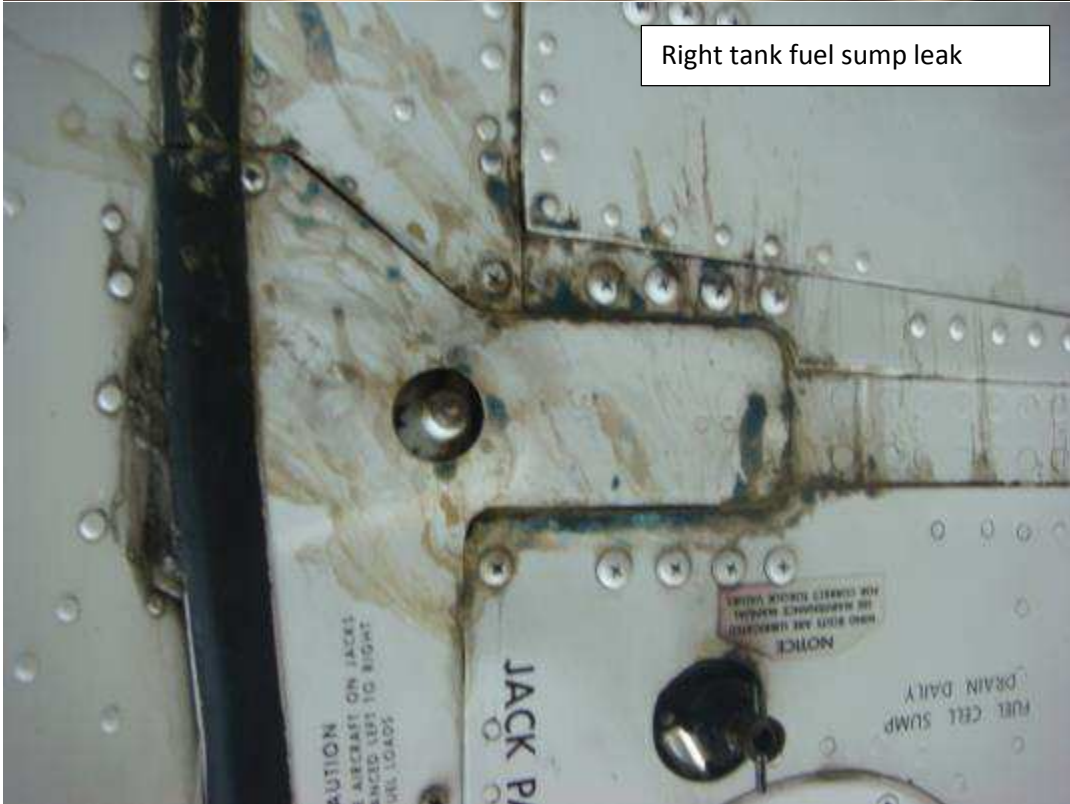
- The right fuel tank inboard sump drain is leaking fuel. Removing the drain and replacing the internal O-rings will stop the leak.
- Fuel cap seals are cracked. These are items that normally get overlooked but should be replaced every annual.

Right tank fuel sump leak

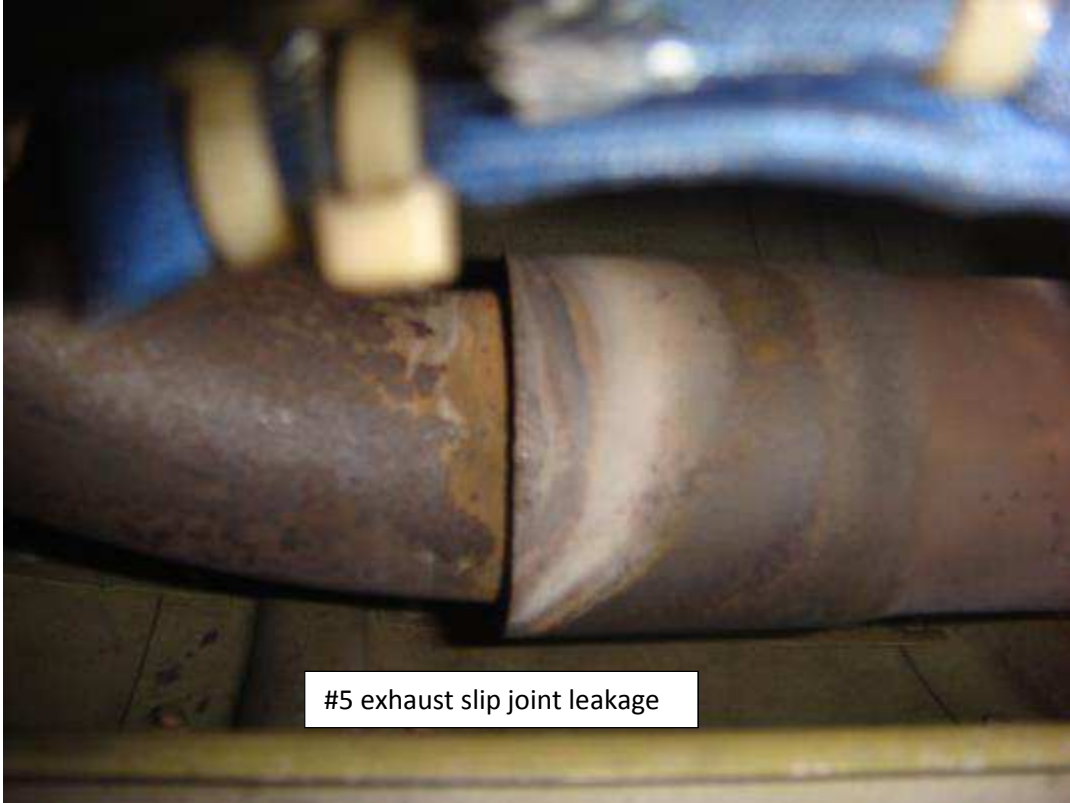
- #5 cylinder exhaust stack on the left engine has an excessive leak on the slip joint where it joins the rest of the exhaust system. While slip joint leakage is normal, the joints should seal up as they expand when the engine warms up. This exhaust slip joint has begun to be eroded away by the hot exhaust gasses. This part can be sent to an exhaust specialty shop for repair.

#5 exhaust slip joint leakage

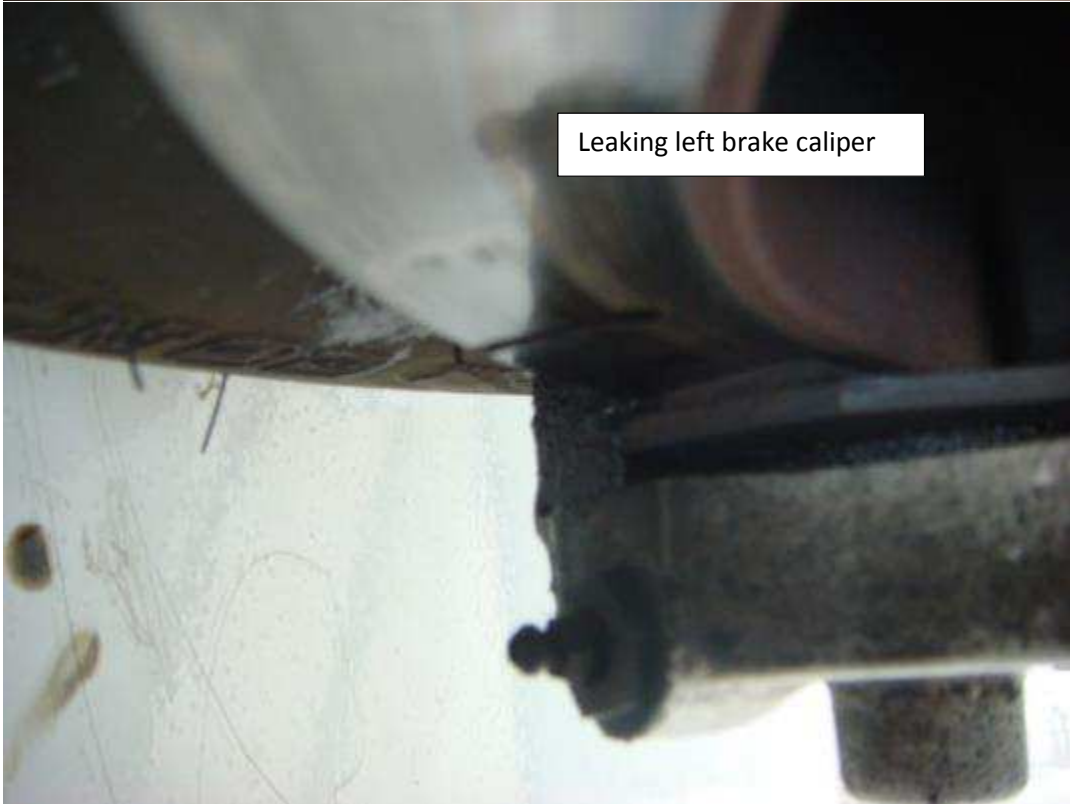
- o Left brake caliper is leaking hydraulic fluid. Although the brakes worked properly, this problem needs to be address immediately to prevent air from entering into the brake lines.

Leaking left brake caliper

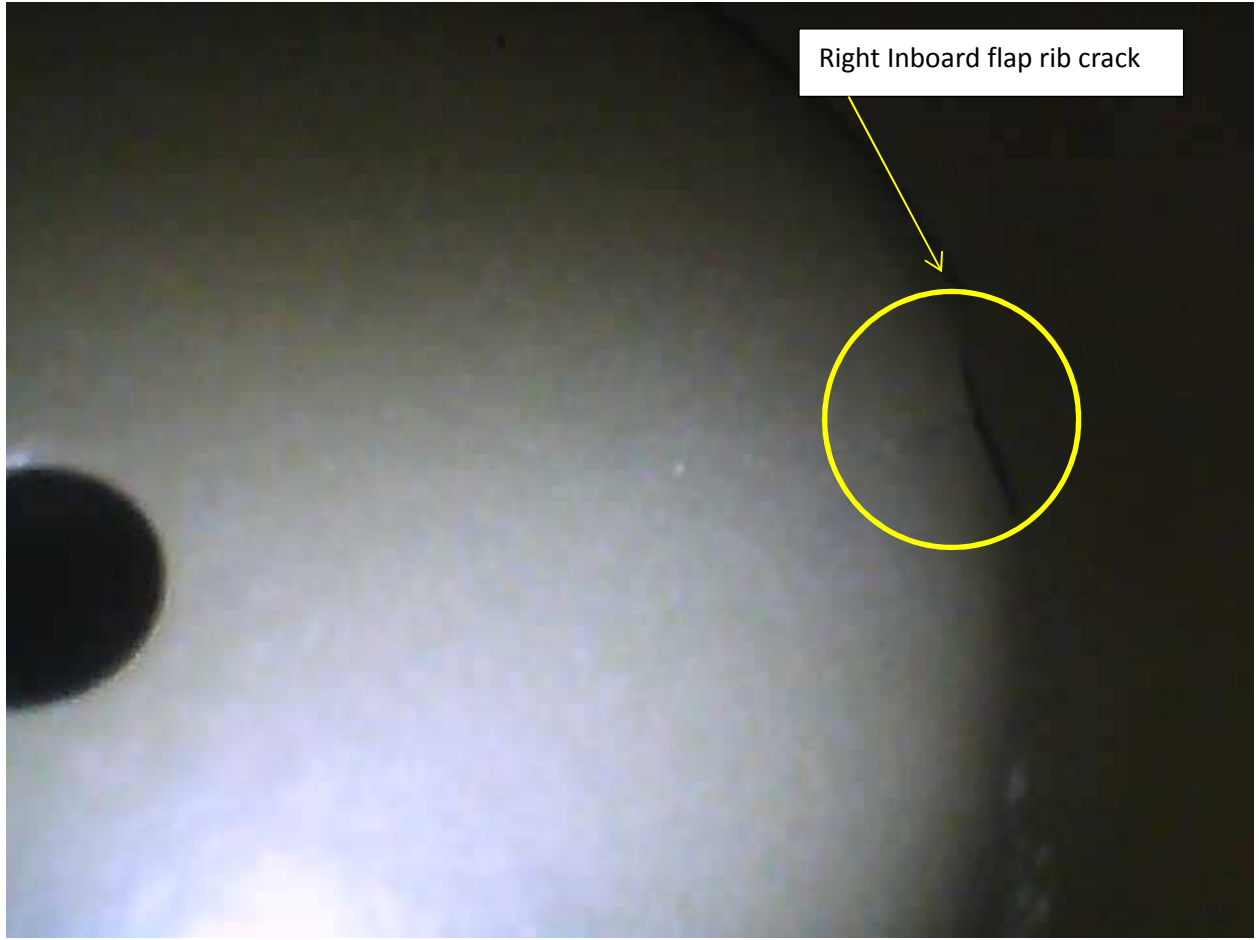
- The right flap inboard rib has begun to crack. This is the point where the actuator attaches to the flap. The crack is caused by people stepping on the flap as they enter and exit the aircraft. If passengers are informed to step only on the wing surface, the life of the flap rib can be extended without repair.

Right Inboard flap rib crack
